# Foster Branch Tributary Improvements Monitoring Report

Prepared for:  
The Harford County  
Department of Public  
Works

January 2005

Prepared by:  
KCI Technologies Inc.  
10 North Park Drive  
Hunt Valley, MD  
21030

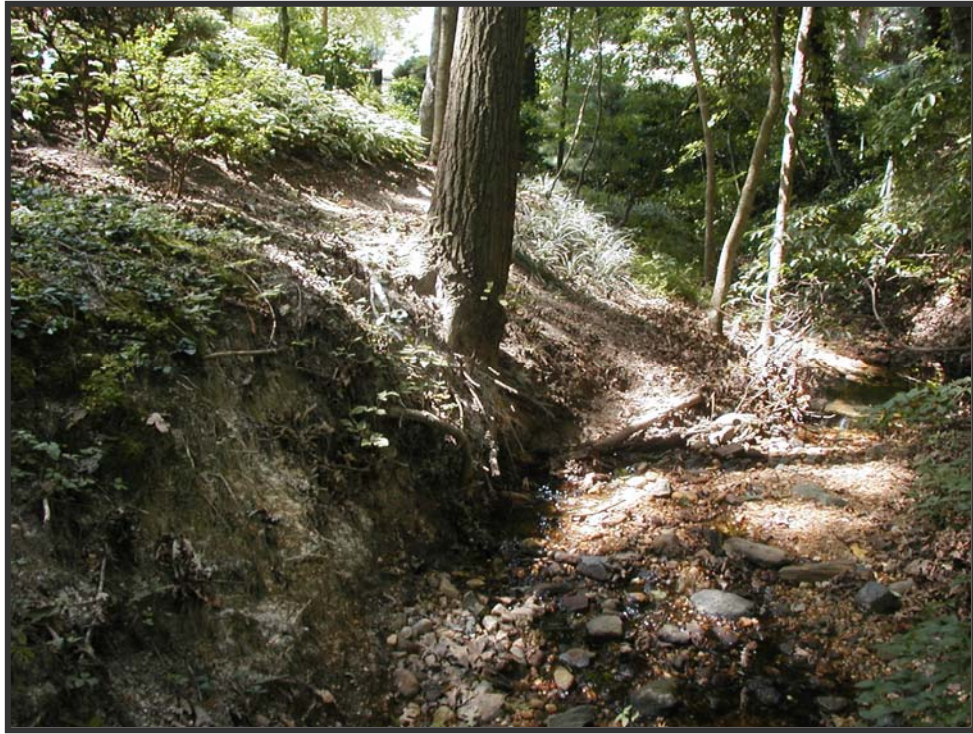
Photo 1 – Existing bank conditions, downstream near Foster Knoll Drive, facing upstream, September 2004

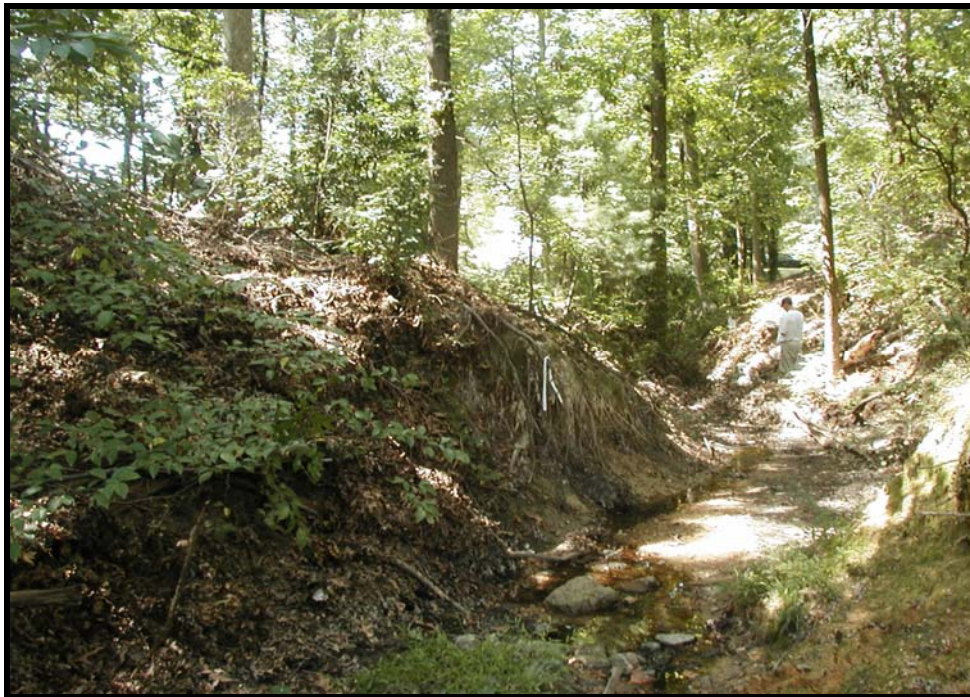
Photo 2 – Existing bank conditions, downstream near Foster Knoll Drive, facing upstream, September 2004

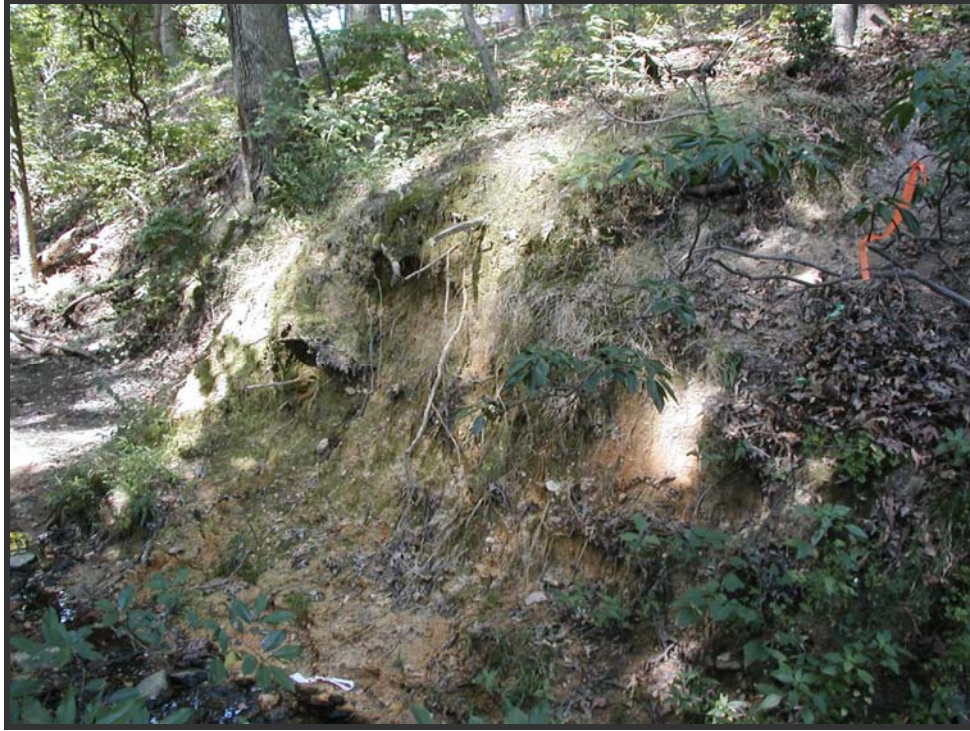
Photo 3 – Existing bank conditions, downstream near Foster Knoll Drive, facing upstream, September 2004

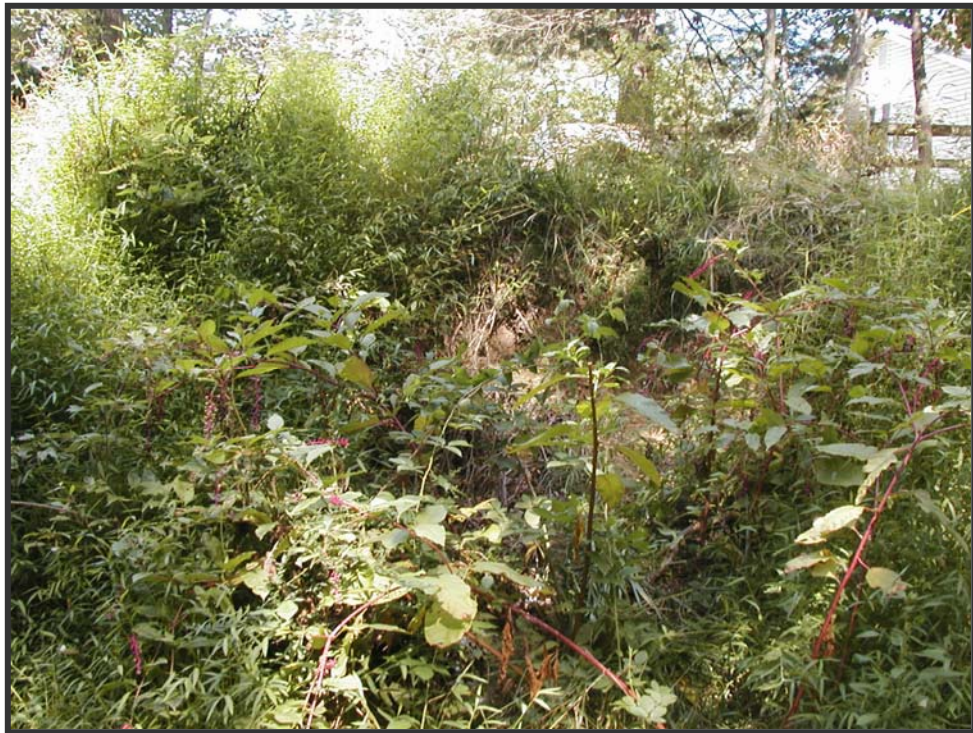
Photo 10 - Station 5+50 to 5+65, slumped left bank, facing downstream, September 2004

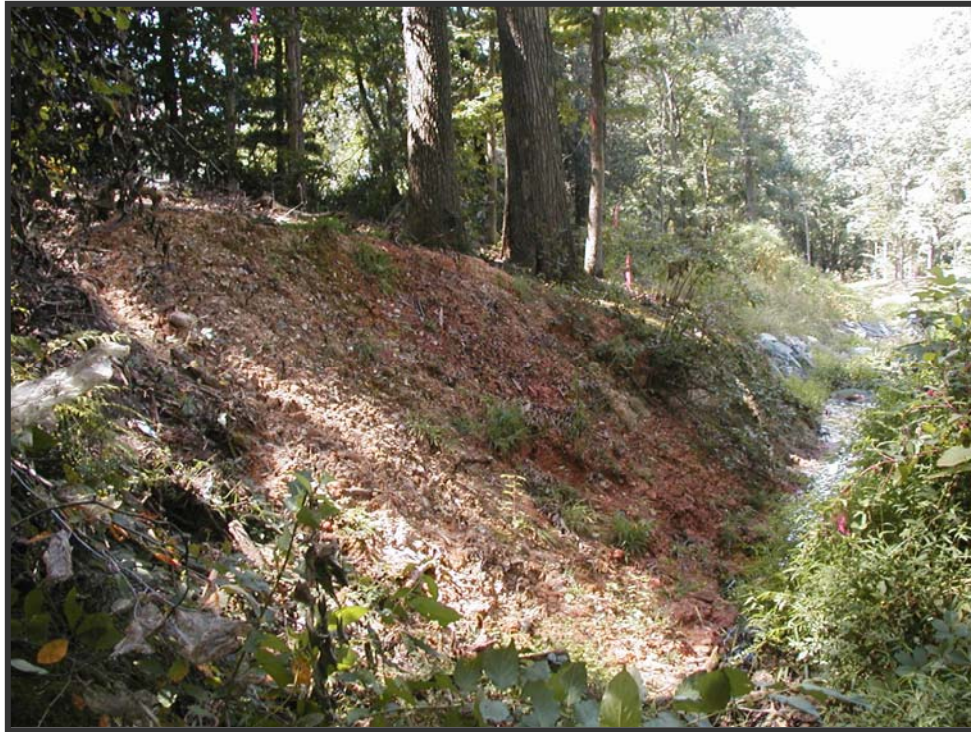
Photo 11 - Station 5+50 to 5+65, un-vegetated bank, facing downstream, due to yard debris/waste, September 2004

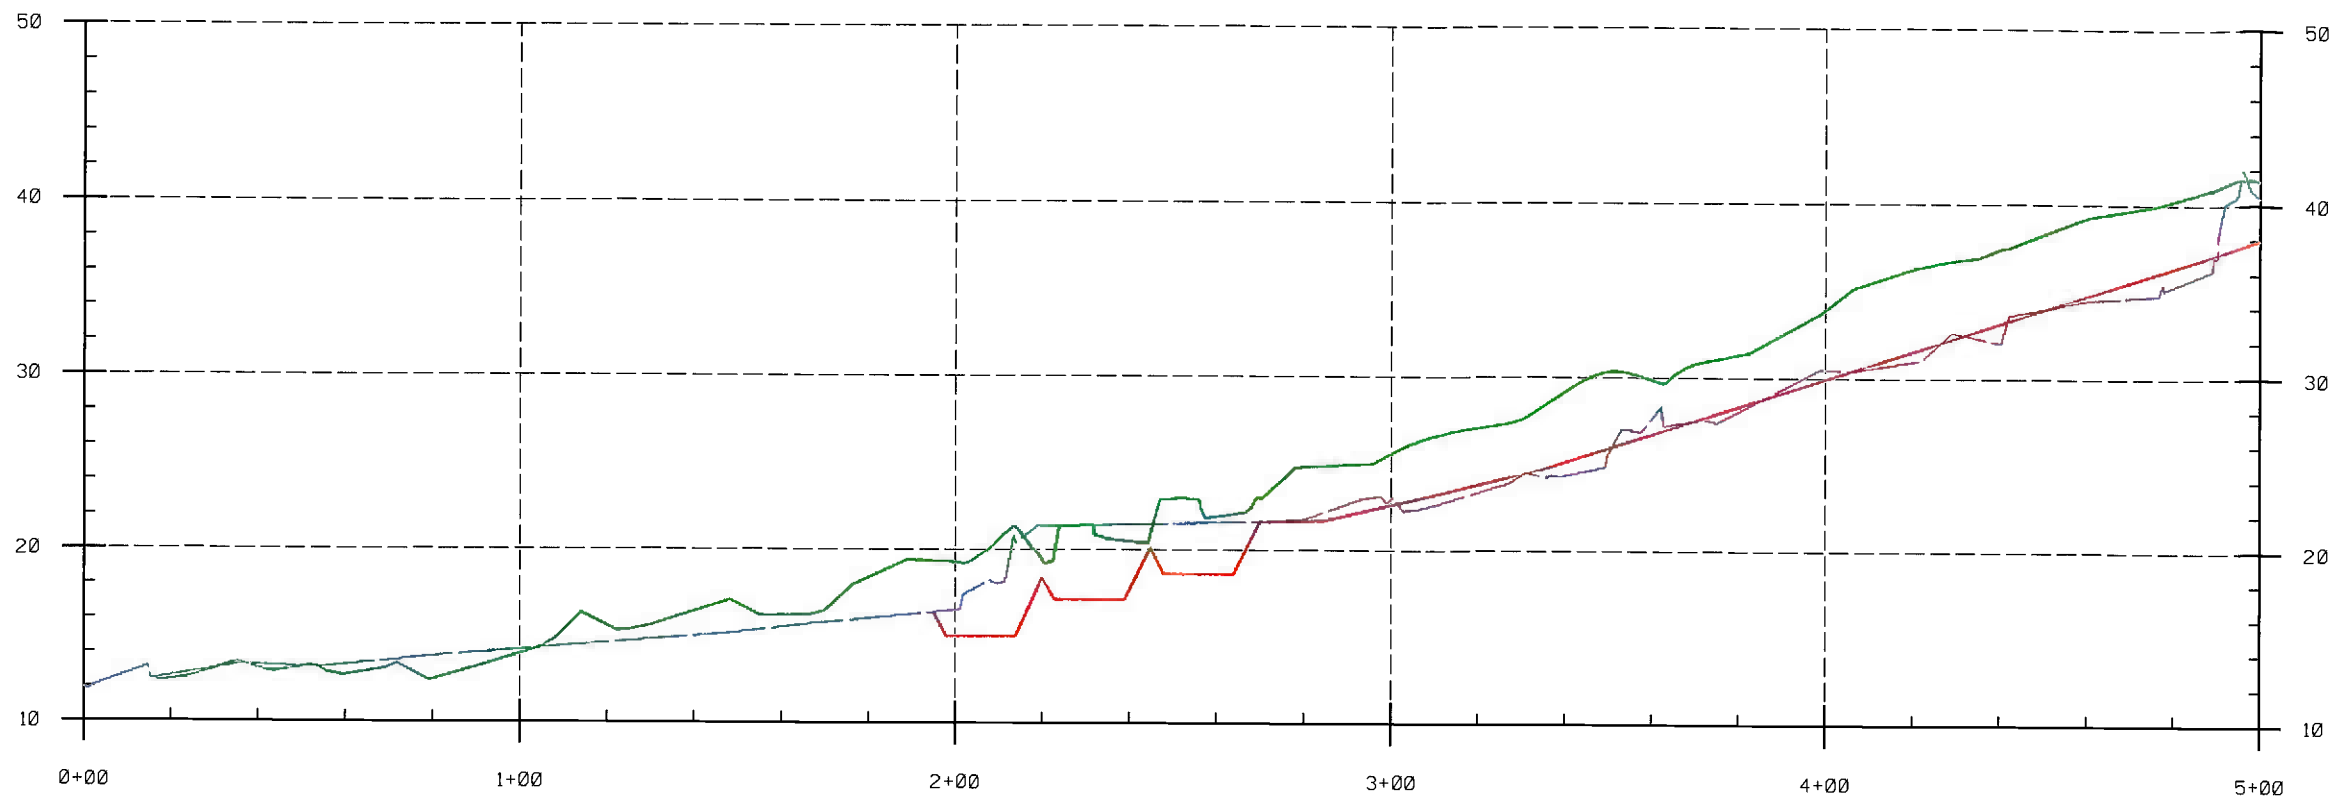
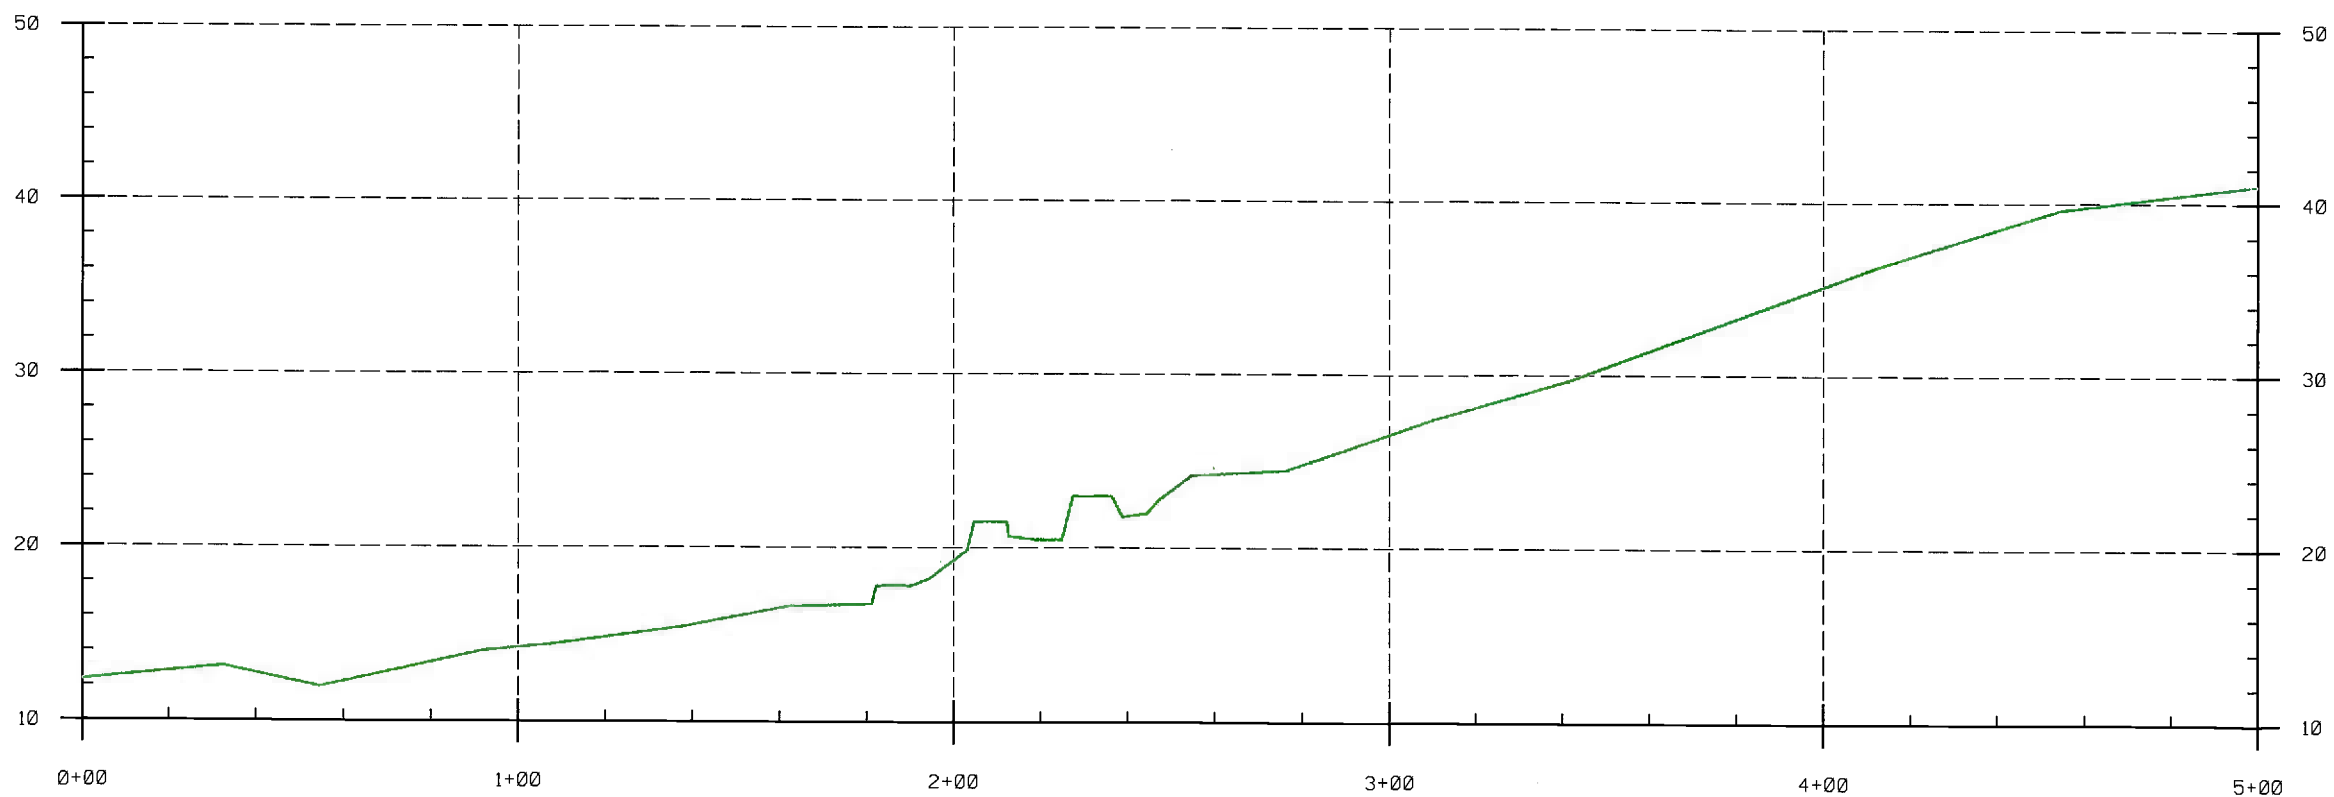
As shown in Appendix C, the 2004 survey data indicates that the channel, from stations 1+75 to 5+50, is approximately three feet higher than the proposed design. This discrepancy could lead to localized velocity and erosion problems. Typically, discrepancies of this magnitude may indicate errors during construction, such as grading of the subgrade to final grade elevations and then placing stone over the final grade. Whether or not this occurred at the site could not be

determined at the time of this report submittal. However, further investigations will be conducted during year two monitoring.
